The Q Townhomes, Sarasota, FL

Modern multi-unit townhome development featuring painted stucco exteriors, decorative metal siding, tile accent walls, and garage doors.

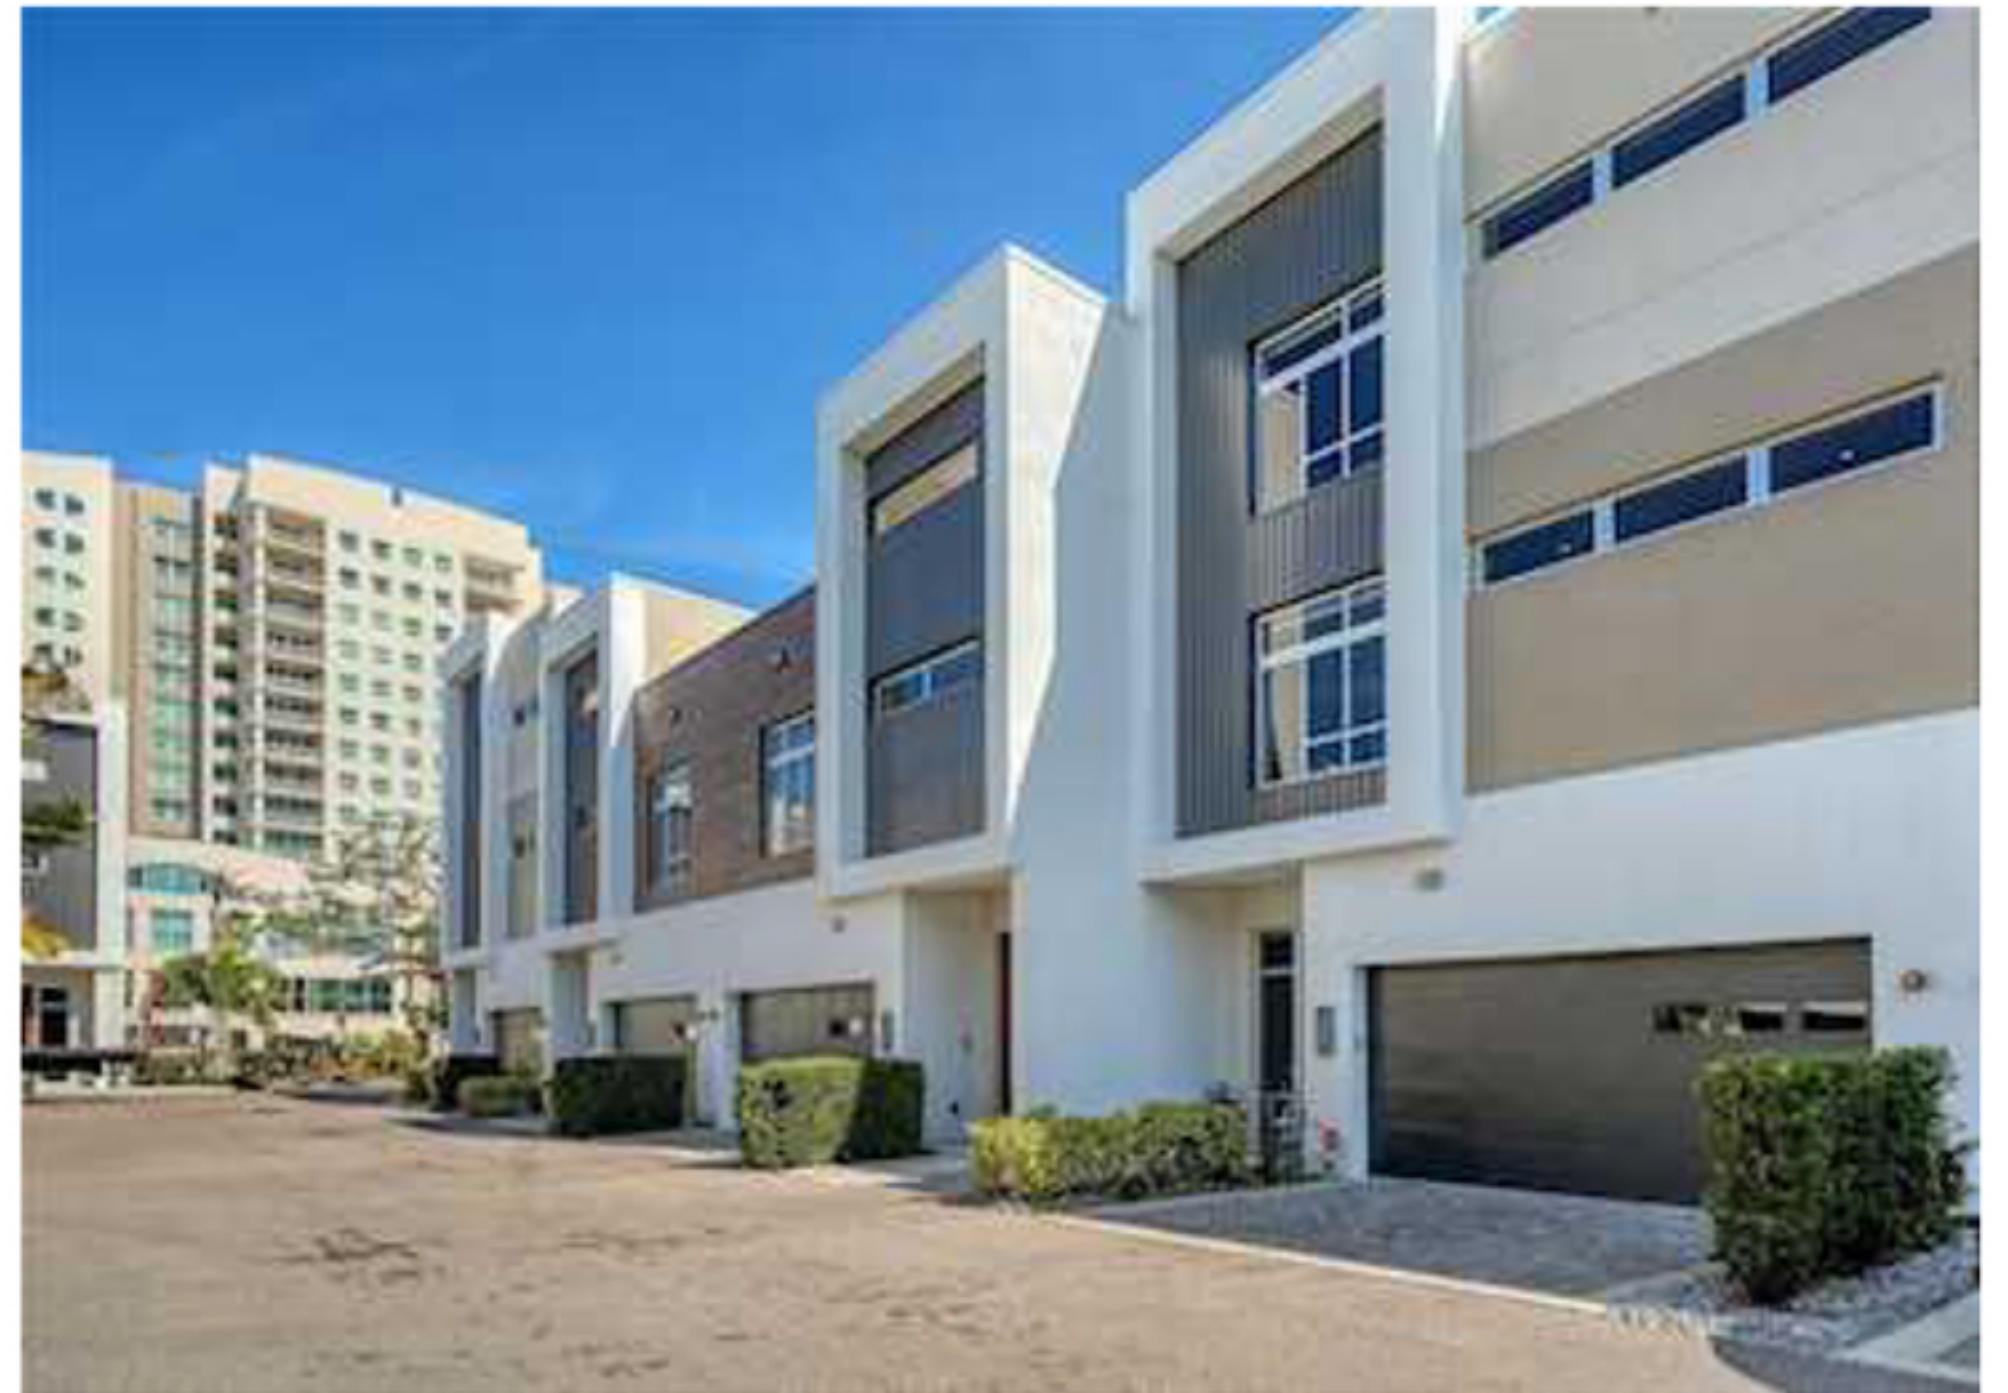
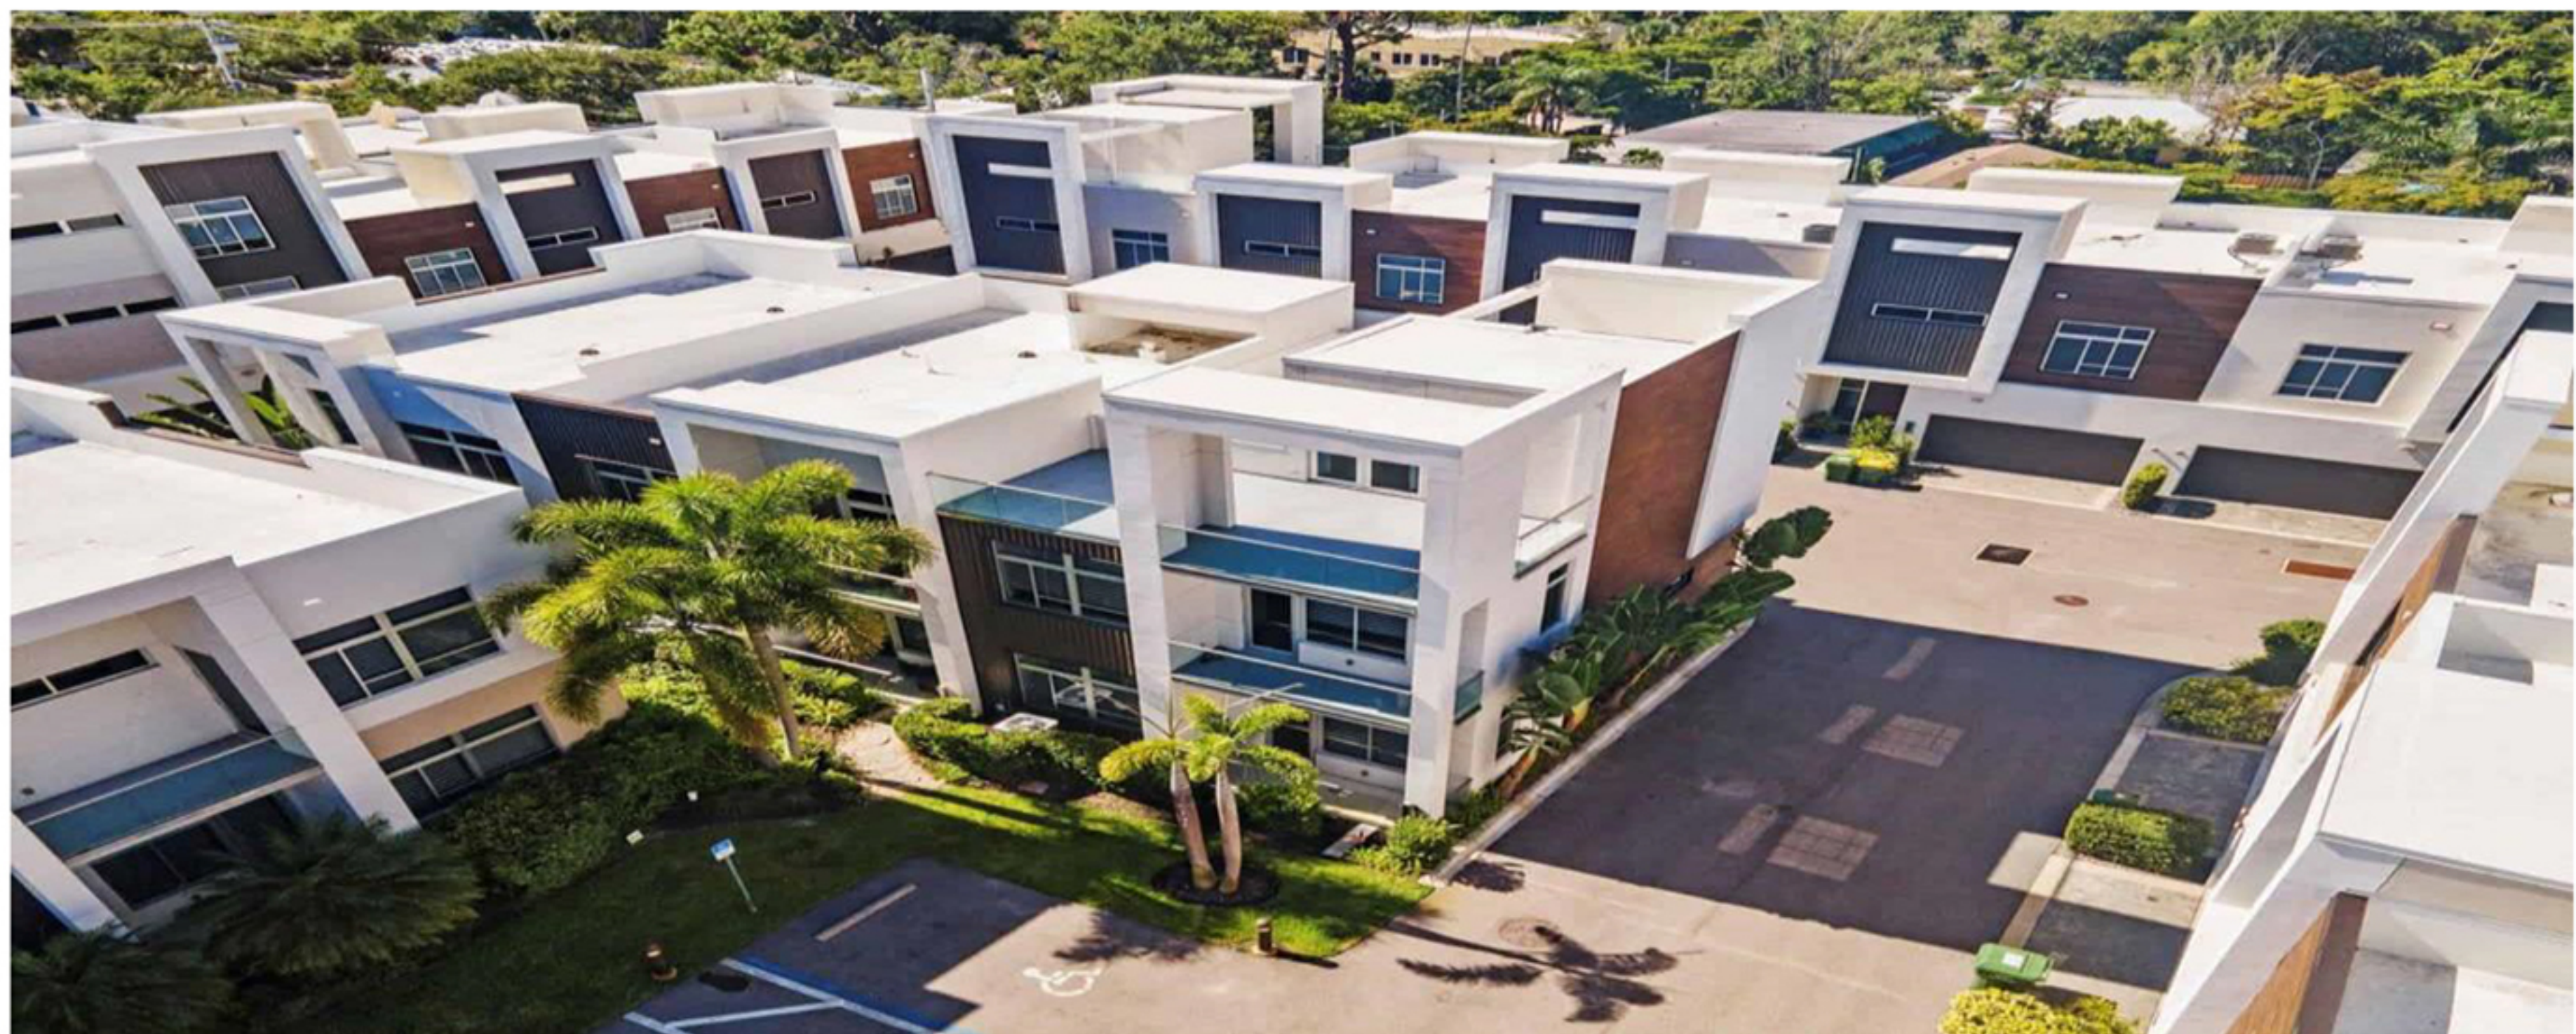
Failed sealants were discovered at window perimeters that had been concealed behind decorative metal siding fastened to concrete block walls. These hidden conditions created water intrusion risks and required careful removal to access the joints. Additionally, several tile accent walls were failing due to insufficient mortar coverage during original construction, leading to loose and delaminating tiles.

Decorative metal siding was carefully removed to access and remove all failed perimeter window sealants. New high-performance urethane sealants were installed, and the metal was reattached. All failing tile walls were removed and replaced with new tile using full mortar coverage to ensure lasting adhesion. The project concluded with a full exterior repaint, including all stucco surfaces, metal elements, and garage doors, restoring both aesthetic appeal and long-term protection.
