Sunset Beach, Longboat Key, FL

Gulf-front condominium complex consisting of three mid-rise buildings and clubhouse. Stucco over masonry.

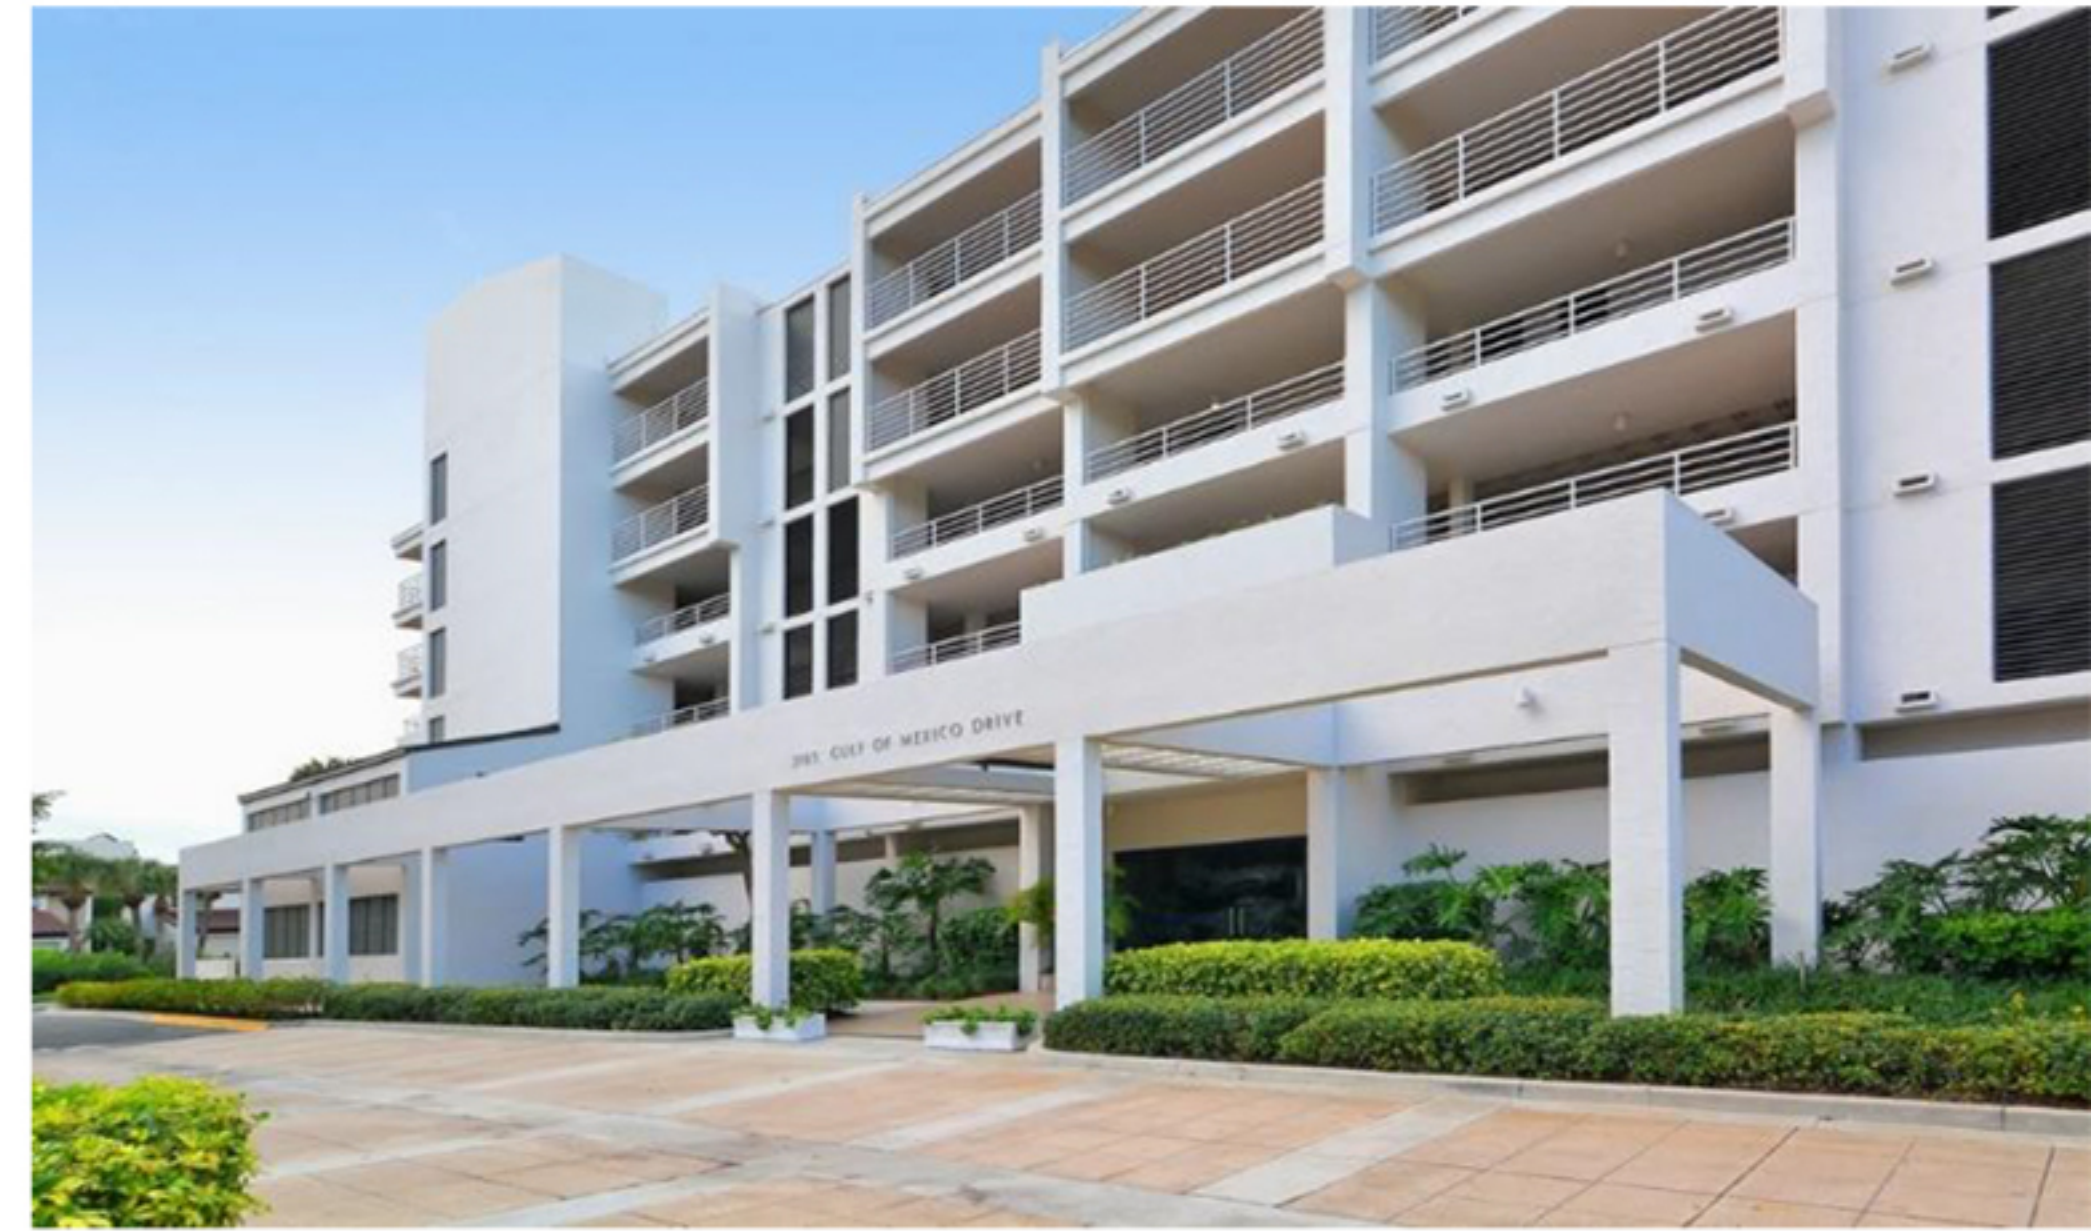
The saltwater environment had severely impacted the building's exterior. Extensive stucco damage was present due to rusting wire lath and rebar. The existing coatings had exceeded their service life, resulting in corrosion, color fading, and heavy oxidation. Sealants throughout the structure had also failed, compromising waterproofing and joint integrity.

All compromised sealants were removed and replaced to reestablish a watertight envelope. Stucco repairs were performed where rust damage had occurred. The building was then fully recoated using high-performance exterior coatings designed to withstand coastal exposure, halt corrosion, and deliver long-term color retention and surface protection.
